235-00: Case Narrative

Case Vehicle (A): 1998 Subaru	Vehicle (B): 1994 Toyota
Type: Legacy Outback, 4-door station wagon	Type: Camry, 4-door sedan
Driver: 34-year-old male	Driver: 27-year-old female
CDC: 12-FYEW-3, 00-RDAO-3	CDC: 12-FYEW-3

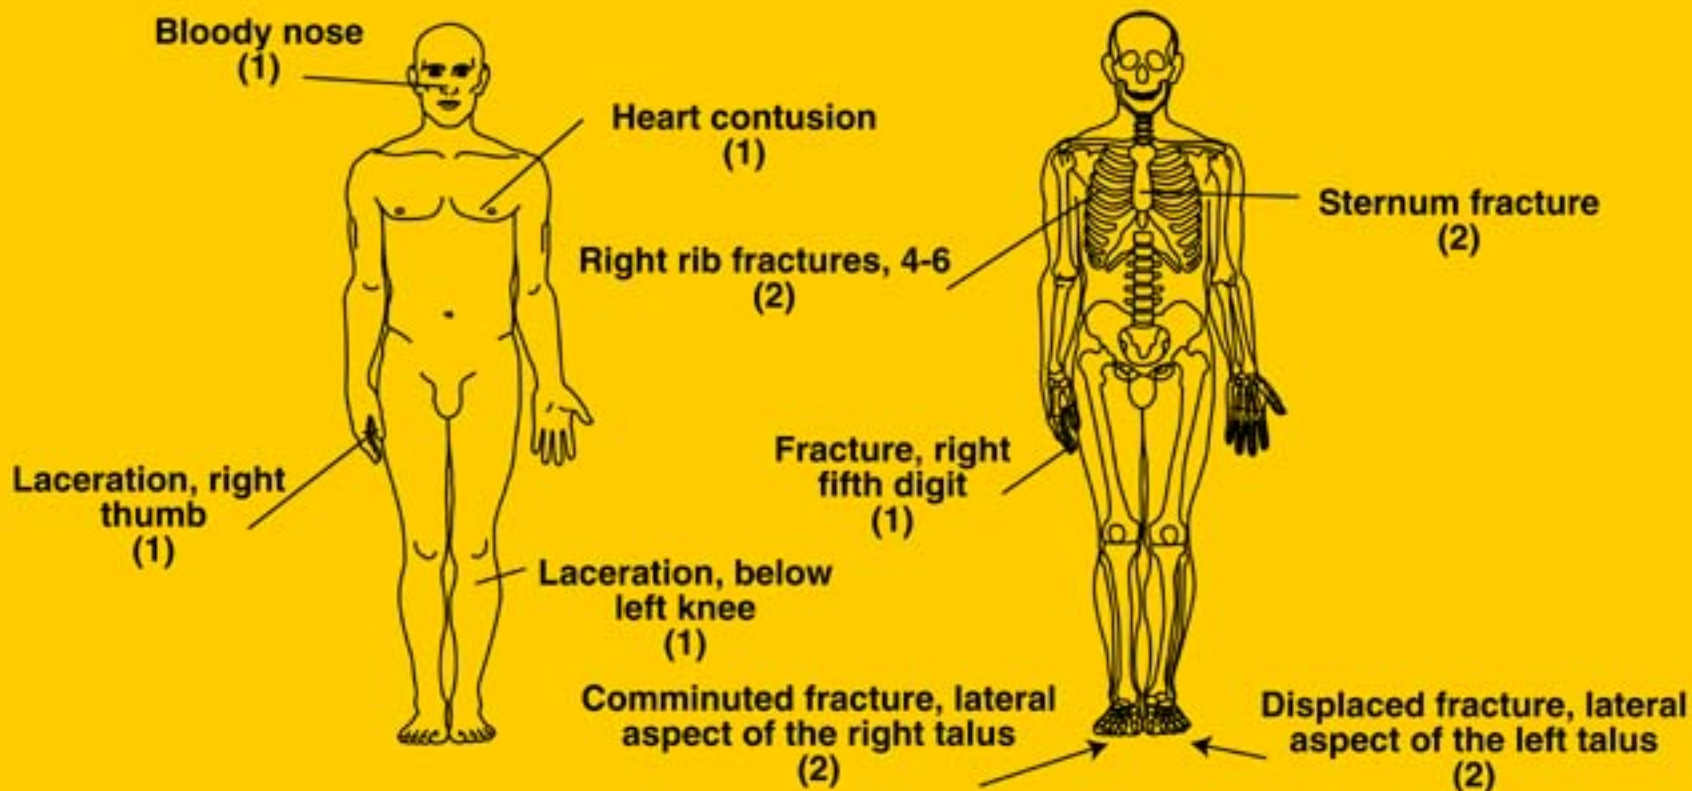
Occupant: Driver	Age: 34 years	Gender: Male		
Restraints: 3-point belt <u>not</u> worn; airbag deployed	Stature: 173 cm (5 ft, 8 in)	Mass: 72 kg (160 lb)		
Injury Description	A.I.S.	Injury Source		
—	—	Definite	Probable	Possible
Bloody nose	1	Airbag	—	—
Heart contusion	1	—	Steering wheel through airbag	—
Right rib fractures, 4-6	2	—	Steering wheel through airbag	—
Sternum fracture	2	—	Steering wheel through airbag	—
Laceration, right thumb	1	—	—	Center instrument panel
Fracture, right fifth digit	1	—	—	Center instrument panel
Laceration, below the left knee	1	Knee bolster	—	—
Displaced fracture, lateral aspect of the left talus	2	—	Toe pan	—
Comminuted fracture, lateral aspect of the right talus	2	—	Toe pan	—
Maximum A.I.S. Level	2	—	—	—
Injury Severity Score	9	—	—	—

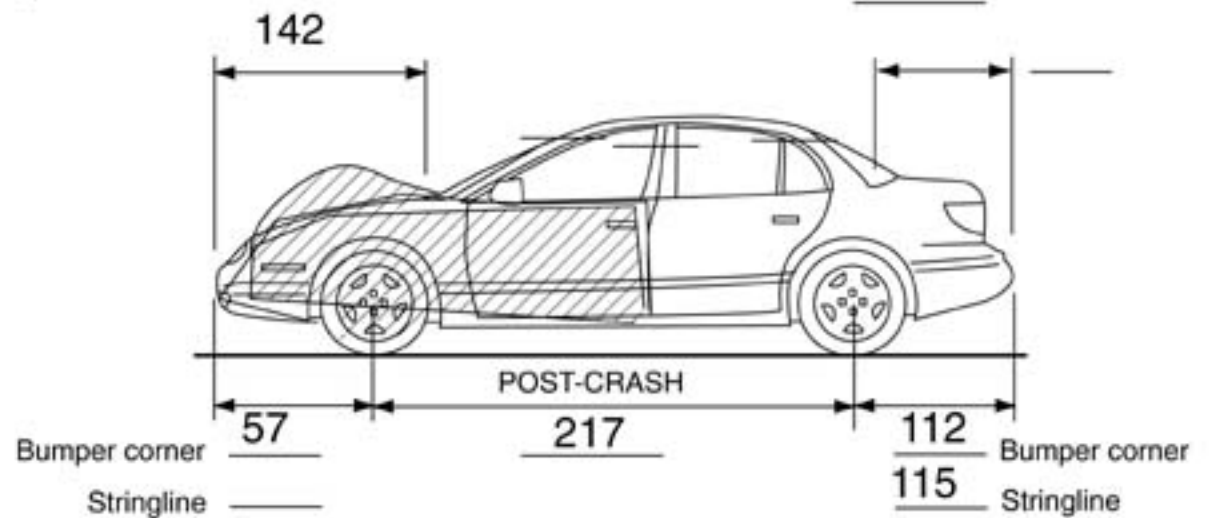
A-pillars cut and roof removed

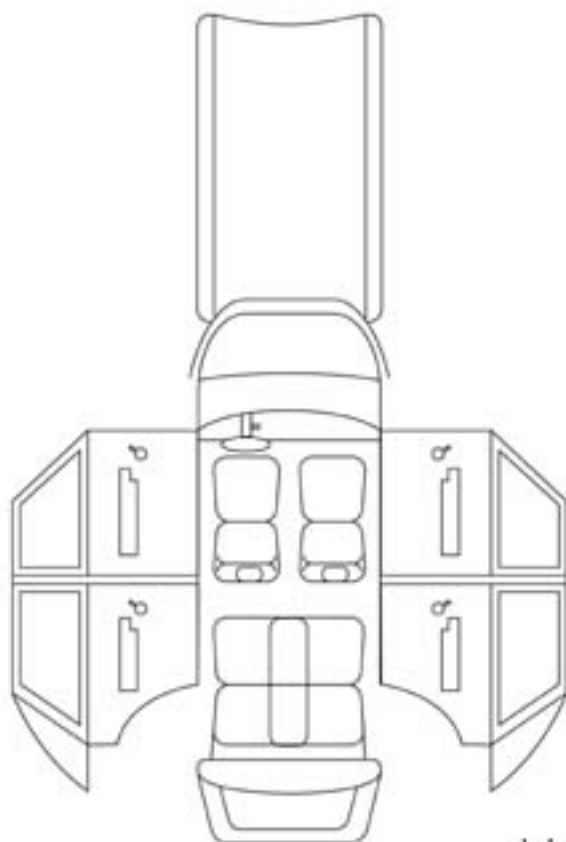
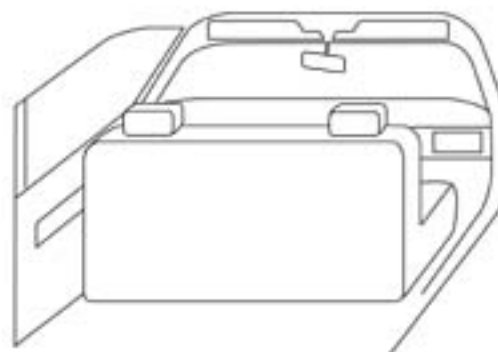
OCCUPANT CONTACT WORKSHEET

dr belt adjusted to full up position

B = steering wheel rim (deformed, bent)

G = airbag (blood)

H = door hardware (damage)

A = door panel (cracked, deformed)

F = door trim lower (damage, intrusion)

D = knee bolster -left and right (scuff marks)

E = floor console (cracked)
